Technical Bulletin TB - 0109

Re: Cracked Cylinder

Affected: All Trailer Mounted 120's Produced since 1985 to Present

Mandatory Safety Check – 120M/H/T

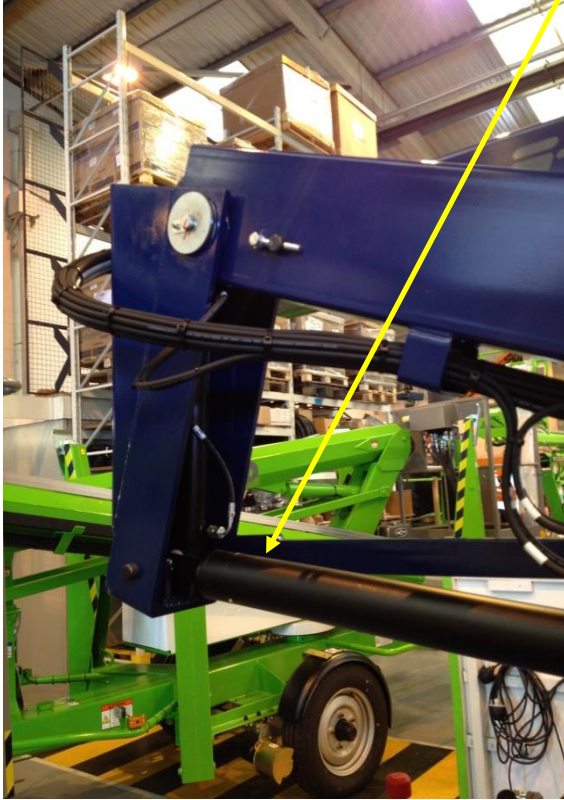
Fig 1.

It has been identified that over time lift cylinder 2 (fig.1) may suffer from material fatigue around the shaft pivot point (fig.3). Our findings point to a number of potential factors that may contribute to this fatigue such as vibration through road transport, lack of boom travel clamp and impact to the machine structure.

Cylinder Location:

In light of this, it is recommended that in addition to the daily/weekly/monthly inspections an additional visual inspection of the cylinder must take place immediately. The cylinder can be visually inspected at rest on the upper surface, then again for the bottom surface by operating the cylinder in question to full height. During the inspection, if the paint surface has not cracked then no further action is required. Should the paint show signs of cracking then removal of the paint would be required for a closer inspection of the chrome shaft.

Any cylinder found to show signs of cracking must be replaced immediately and the machine load tested.

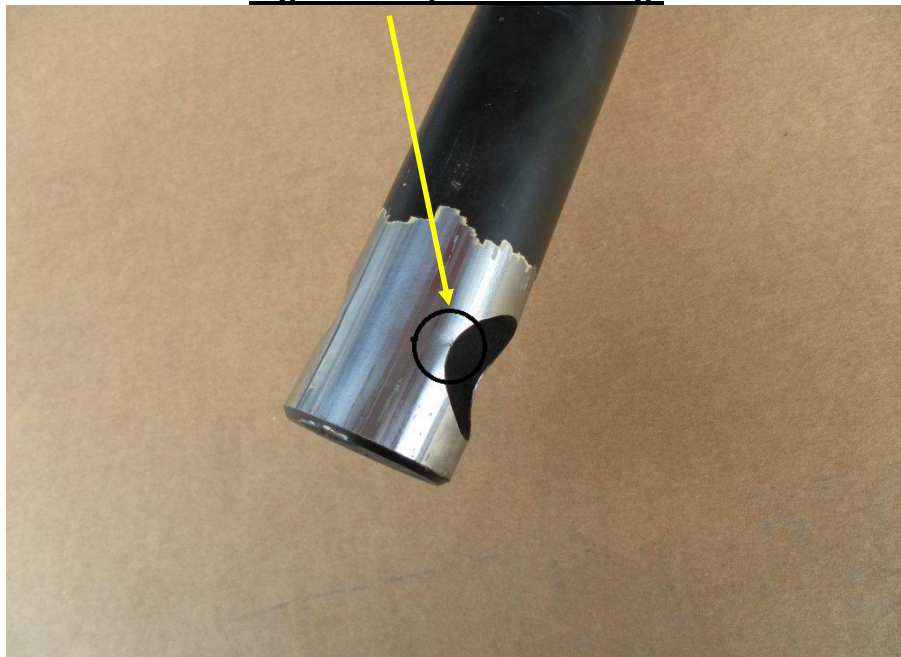
Fig 3. Example of cracking:
