Technical Bulletin TB - 0109

Re: Cracked Cylinder

Affected: All Trailer Mounted 120's Produced since 1985 to Present

Mandatory Safety Check – 120M/H/T

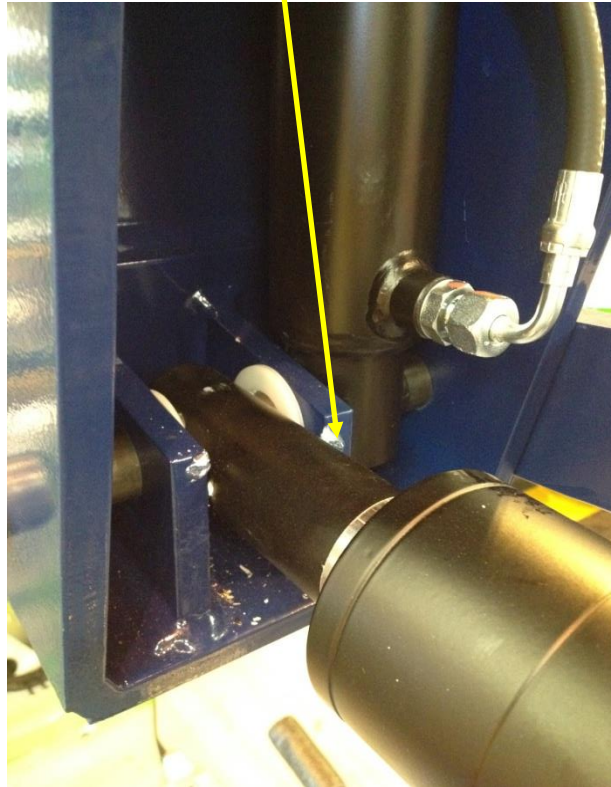
Fig 2

It has been identified that over time lift cylinder 2 (fig.1) may suffer from material fatigue around the shaft pivot point (fig.3). Our findings point to a number of potential factors that may contribute to this fatigue such as vibration through road transport, lack of boom travel clamp and impact to the machine structure.

In light of this, it is recommended that in addition to the daily/weekly/monthly inspections an additional visual inspection of the cylinder must take place immediately. The cylinder can be visually inspected at rest on the upper surface, then again for the bottom surface by operating the cylinder in question to full height. During the inspection, if the paint surface has not cracked then no further action is required. Should the paint show signs of cracking then removal of the paint would be required for a closer inspection of the chrome shaft.

Any cylinder found to show signs of cracking must be replaced immediately and the machine load tested.
